“STRUCTURAL POST-DISASTER DAMAGE CLASSIFICATION WI CONSIDERATION OF LIQUEFACTION DUE TO FLOOD: MANEK UR KELANTAN, MALAYSIA”

Keywords: Building damage, Flood, Kelantan, Matek urai, Disaster, Liquefaction, Damage survey.

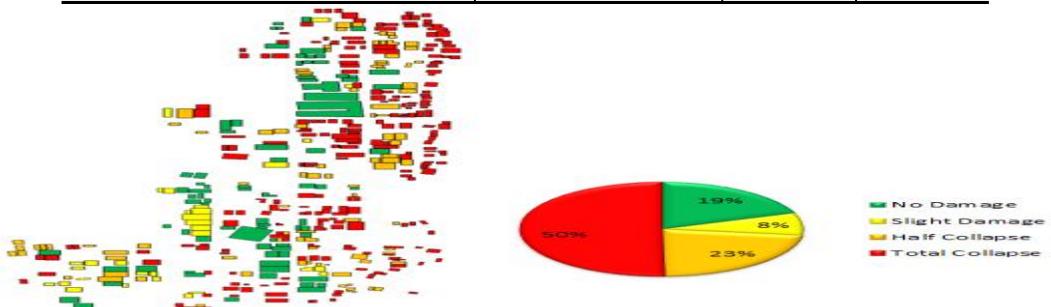
Figure-4. Distribution of total collapse rate in Manek Urai area and target area of the classification study

The building damage patterns classifications in the study area using the damage chart is shown in Figure 4. Consequently, the proportion of total collapse is high at 50.3%. These photographs are including all buildings. However, it can be considered that damaged buildings were the main objects of the photographs. The numbers of the buildings in the study area are given in Table 2. Total of 376 buildings and their positions were confirmed from 1980 photographs. The damage chart made by Okada and Takai was for wooden structures and in Manek Uai, Kelantan area the majority of the structures are wooden, therefore, we investigated building damage to 179 wooden structures and classified the damage pattern of these buildings.

Total number of surveyed buildings		376	
Total number of photographs		1980	
Number of the studied buildings	Wooden structures	179	47.6%
	Concrete structures	88	23.4%
	Masonry structures	109	28.9%
Survey by Universiti Teknologi Malaysia, Department of Quantity Surveying, (QS-UTM)	No Damage	73	19.4%
	Slight Damage	29	7.7%
	Half Collapse	85	22.6%
	Total Collapse	189	50.3%
