Review of Information Engineering and Applications

INVESTIGATE OF MECHANICAL FUSE IN CARDAN SHAFT USING FEM

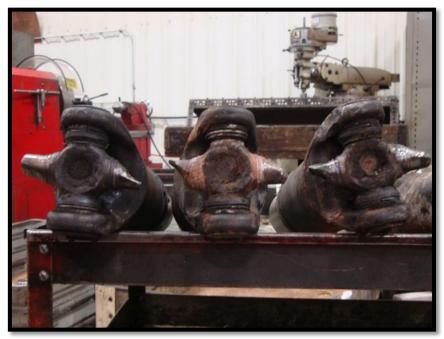
Fig-12. Three cardan shafts that belong to Danaand all of them failed at the cross shaft due to overload

As it is illustrated at the following figures, and as it is clear, the part of a cardan shaft that fails first due to applied overload is the cross shaft.

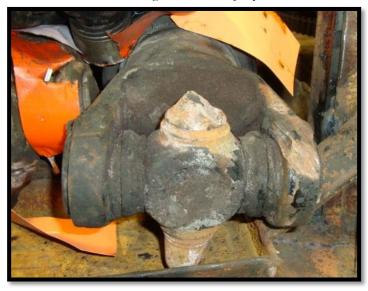
Fig-14. A cardan shaft that belongs to Elbe company that failed at cross shaft.
