ASSESSMENT OF ENVIRONMENTAL EFFECT OF ABANDONED URANIUM MINE SITE IN MIKA VILLAGE OF TARABA STATE NIGERIA

Oruonye, E. D.^{1*}
Ahmed, M.Y.²

^{1,2}Department of Geography, Taraba State University, Jalingo, Taraba, Nigeria

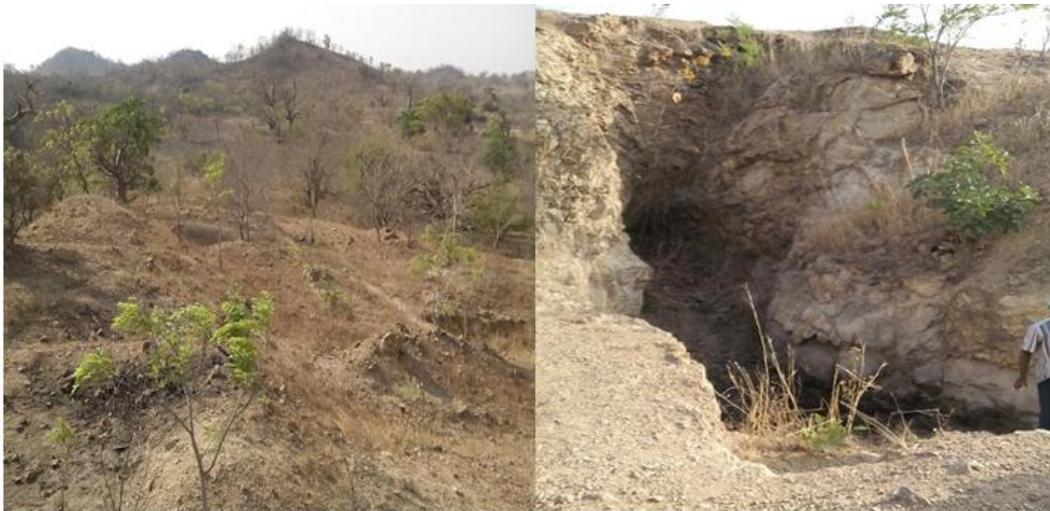
The uranium mine site is about 3km away from Mika village. The uranium ore is found on hill top (Plate 1a and 1b). The elevation at the foot of the hill is 405masl and hilltop is 425masl. The area of the uranium mining is about 2km² allocated specifically by the Federal Government of Nigeria for uranium mining in the locality. There are many uranium open mine pits in the area. However, during the field observation, only 3 abandoned open mine pits (plate 2a and 2b) were seen with the following pit dimensions (Table 1). The mine wastes and overburden were deposited around the mine pits. Most of the overburden materials have been washed away.

Plate-1a and 1b. Mika Uranium mine site

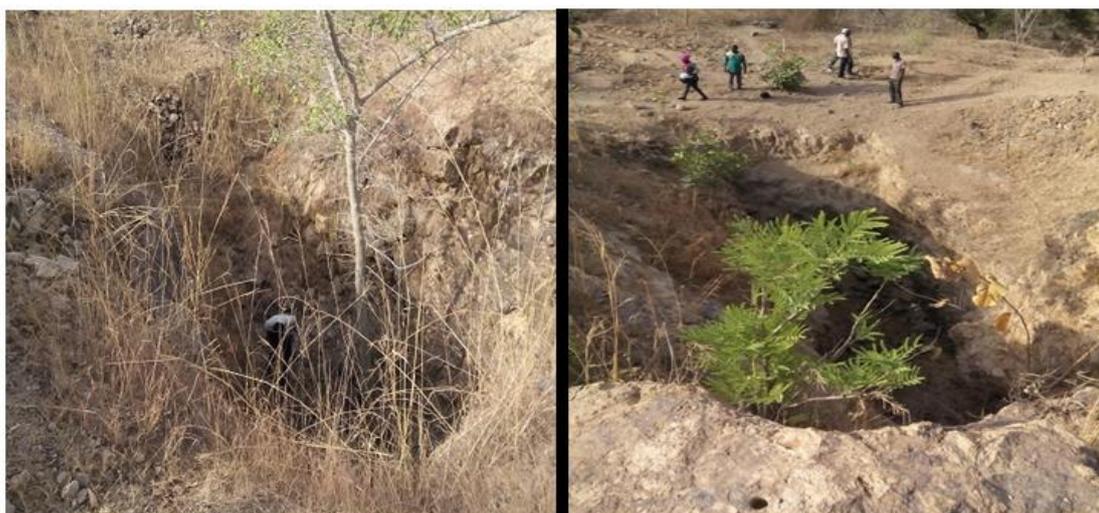
Plates-2a and 2b. Abandoned uranium mine pits at Mika

Table-1. Dimensions of abandoned open uranium mine pits.

S/N	Pits No.	Coordinates	Depth (m)	Length (m)	Width (m)
1	X1	08° 58' 46"N, 11° 36' 23"E	5.9	9.7	7.0
2	X2	08° 58' 47"N, 11° 36' 23"E	1.3	5.5	4.4
3	X3	08° 58' 47"N, 11° 36' 23"E	5.9	12.9	7.1

The dependence of the surrounding communities on the collected water in the abandoned uranium mine pits for human consumption and domestic use is a potential source of threat to the health of the communities. This is because the collected water in the abandoned uranium mine pit may likely contain heavy metals such as iron, manganese, aluminium, copper, chromium, zinc, lead, vanadium, cobalt or nickel etc. The uranium ore deposit at Mika village is said to be stable at the moment which could be a factor to non visible health impact observed by the local communities.

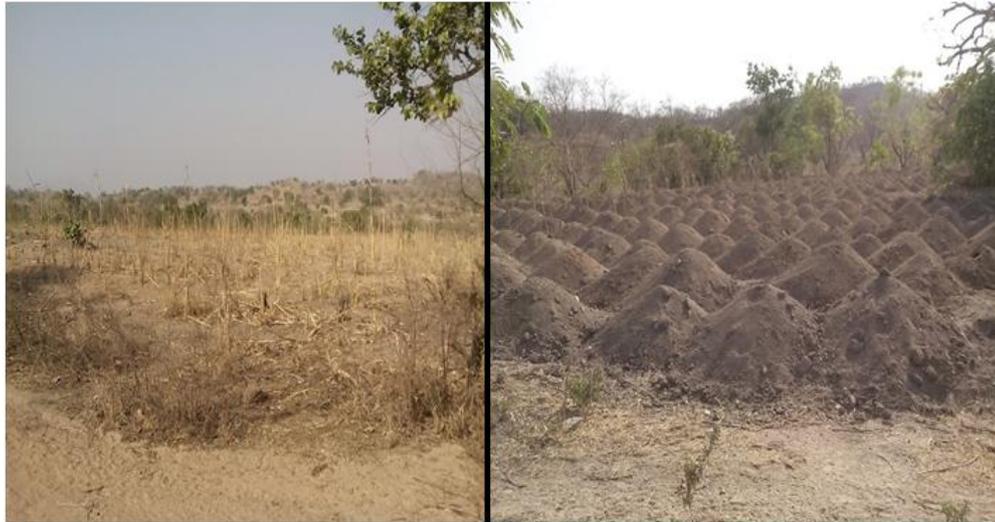
Plate-3a and 3b. Maize and yam cropland around Uranium Mine site

The ecological effects of uranium mining in the area were observed on crops, trees and humans. The crop yield in the area is very low as a result of soil poisoning by radio activity associated with the uranium ore deposit in the area. Radio activity associated with uranium causes infertility.

When they villagers were asked whether they have observed any unusual health challenges in the area, they people claimed otherwise, insisting that they have not observed any strange health challenges in the area. On the issue of premature death or short lifespan of members of the communities as a result of the radioactivity associated with the uranium ore deposit, the people claimed that there was nothing of such. They insist that their people live their normal life and are hardworking farmers. Most of them are adult farmers with children. One of the key informant interviewed lived 600m away from the foothill of the uranium ore deposit. The key informant claimed that the surrounding communities depend on the water collected in the abandoned uranium mine pit for their domestic consumption (Interview, 2017b). When the water is exhausted, they move to the surrounding streams some distance away from their homes. The key informants claimed he has lived in the area for 3 years. He has a wife and two children. They cultivate the surrounding lands at the foot of the hill of the uranium ore deposit (plate 3aand 3b). Most of the people in the surrounding area are mainly migrant farmers. They move to new location as soon as the soil fertility is depleted for a more fertile land. The uranium mining activities disrupted farming activities in the area. The people initially cultivated the hilltops but with mining activities, the overburdens excavated were deposited on lands formally cultivated by local community members. They people then moved to cultivate the surrounding foothills. Crops cultivated were mainly yam, maize and guinea corn (plate 3aand 3b).
