## **ORIENTATIONAL EFFECTS ON SOILING MEASUREMENTS AT THE SHELDONIAN THEATRE IN CENTRAL OXFORD, UK**

### **ABSTRACT**

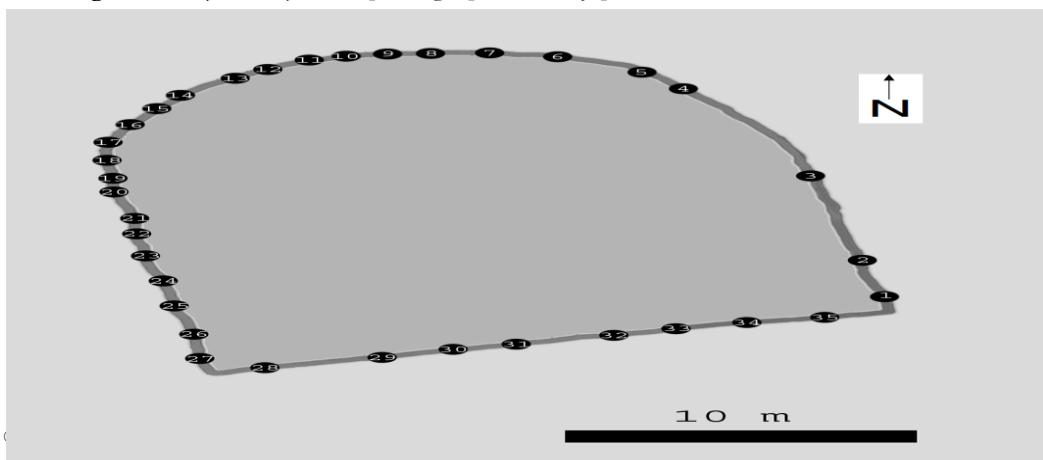
Fig-1. Sites (1 to 35) of the photographic survey performed at the Sheldonian Theatre.

Photographic sites were selected along the building exterior (Fig. 1), where its walls were relatively flat and devoid of architectural features (where possible). A compass reading was taken of the direction which the building wall faced (for orientation or aspect measurement) at each site. These were later converted to represent east ( $45$  to  $134^\circ$ ), north ( $315$  to  $44^\circ$ ), west ( $225$  to  $314^\circ$ ), and south ( $135$  to  $224^\circ$ ). In this way, Sites 1 to 4 were east-facing; Sites 5 to 20 faced north; Sites 21 to 27 were west-facing; and Sites 28 to 35 faced south. In addition to orientation measurements, a digital light (Lux) meter (LX-1010B) was deployed in the field at a sampling time of 0.4 seconds and Lux ranges of 50,000, with a resolution up to 100 Lux and accuracy at  $25^\circ\text{C} \pm 3^\circ\text{C}$  of  $\pm 5\% + 2d$ . The instrument was calibrated to standard incandescent lamp at color temperature 2,856 K.

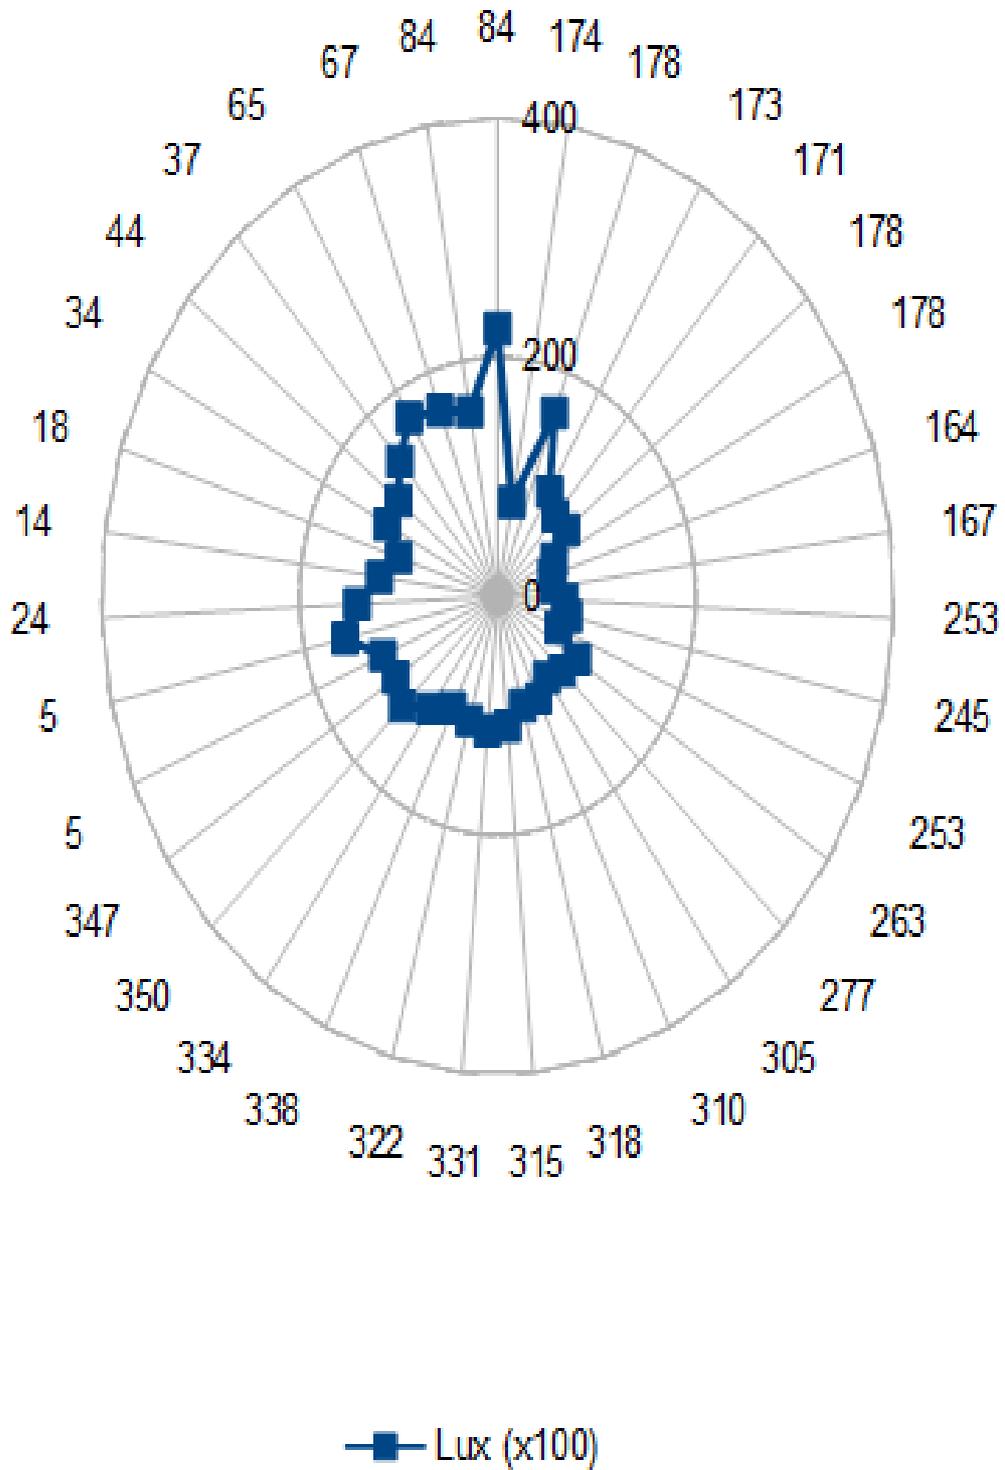
Fig-2. Digital light-meter readings at the different sites of the photographic survey.

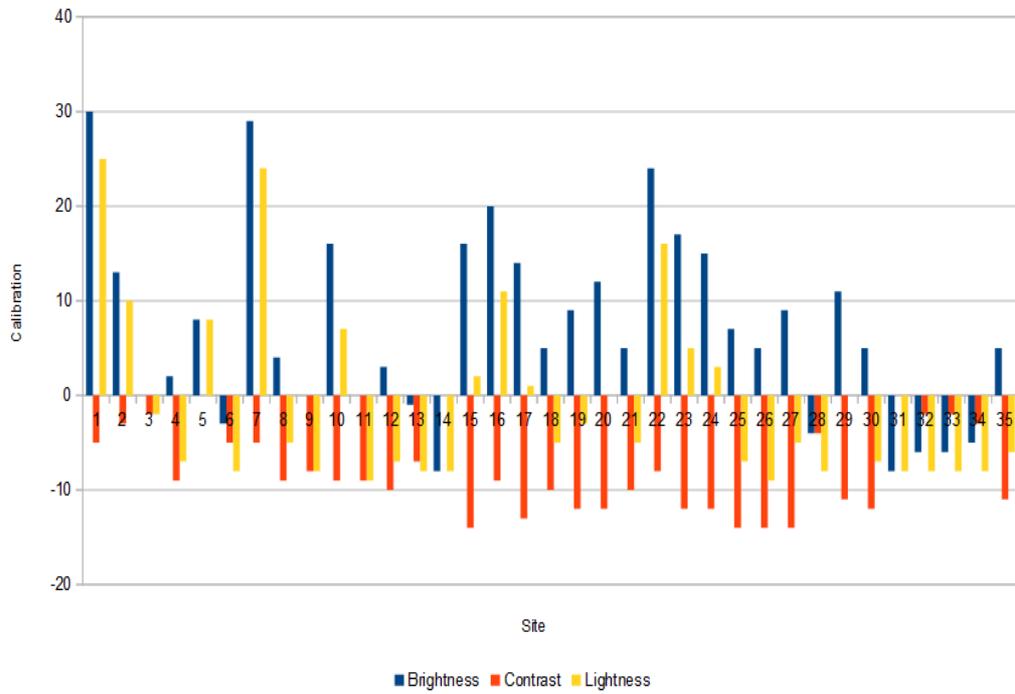
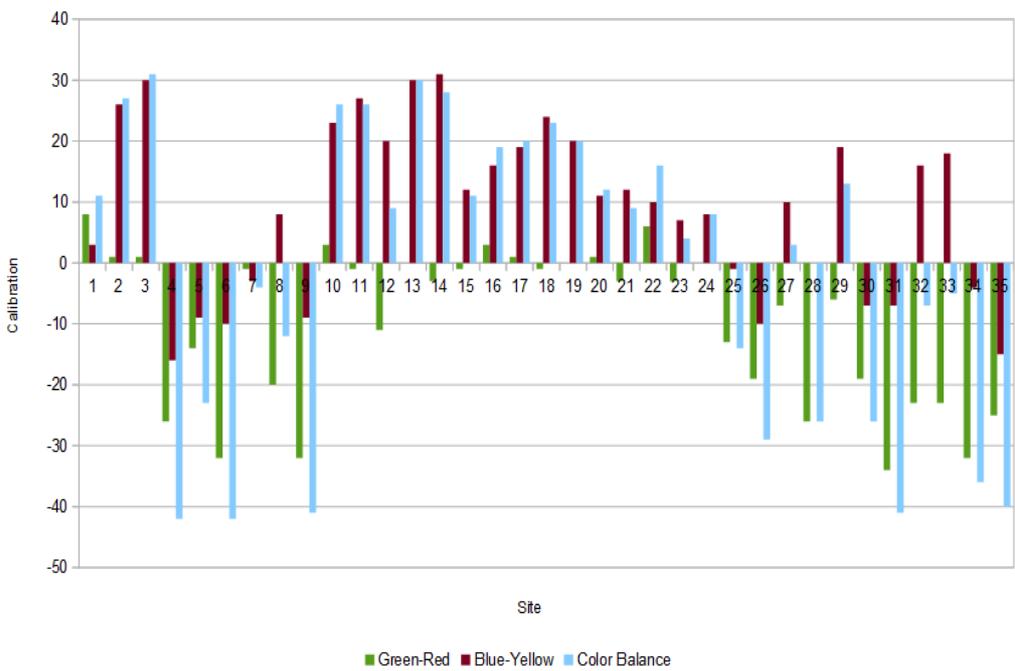
**Fig-3.** Adjustments in the calibration process for lightness ( $L$ ), including brightness and contrast parameters ( $a$ ), as well as adjustments in Color Balance along the green-red and blue-yellow color channels ( $b$ ).

For  $L$ , adjustments were mainly in the negative direction (Fig. 3a). East-facing sites required total adjustments (positive minus negative) of 26; north-facing sites were adjusted by -8 in total; west-facing sites by -2; and south-facing by a total of -53 (a grand total of -37, conveying an overall reduction in  $L$  through calibration). Reductions in the green-red ( $a$ ) color spectrum were -16 for east-facing sites, -108 for north-facing, -39 for west-facing, and -188 for south-facing sites (a grand total of -351 for  $a$ ). This indicates a greening of most sites in the calibration process that is especially pronounced at north- and south-facing sites (Fig. 3b). Along the blue-yellow ( $b$ ) spectrum, 43 increments were made to east-facing sites, 210 for north-facing, 36 for west-facing, and 20 for south-facing sites (for a total of 309), all promoting a yellowing of images, particularly at north-facing sites (see Fig. 3b). Overall Color Balance alterations consisted of 27 changes to east-facing sites, 104 for north-facing, -3 west-facing, and -168 for south-facing sites (a grand total of -40). Total adjustments comprised 53 at east-facing sites, 84 north-facing, -1 west-facing, and -221 at south-facing sites (for a grand total of -85 positive and negative adjustments to lightness and color). This denotes a reduction in lightness (as well as greening and bluing) that is evident particularly at south-facing sites (Fig. 3c). The calibration process had an error margin up to 7% tested on lightness.

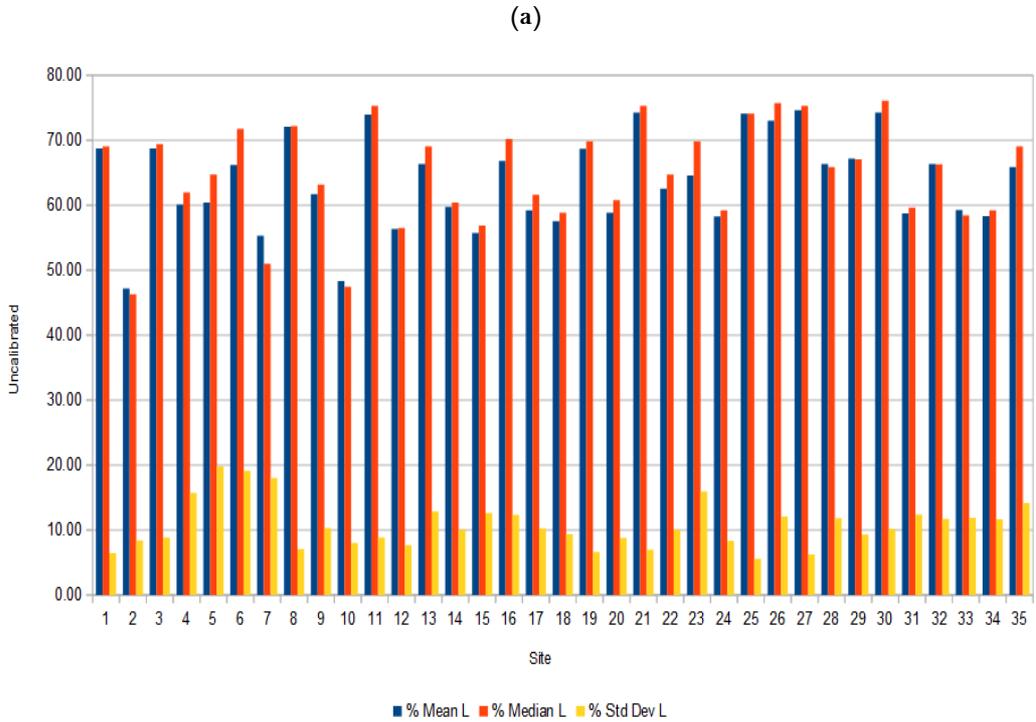
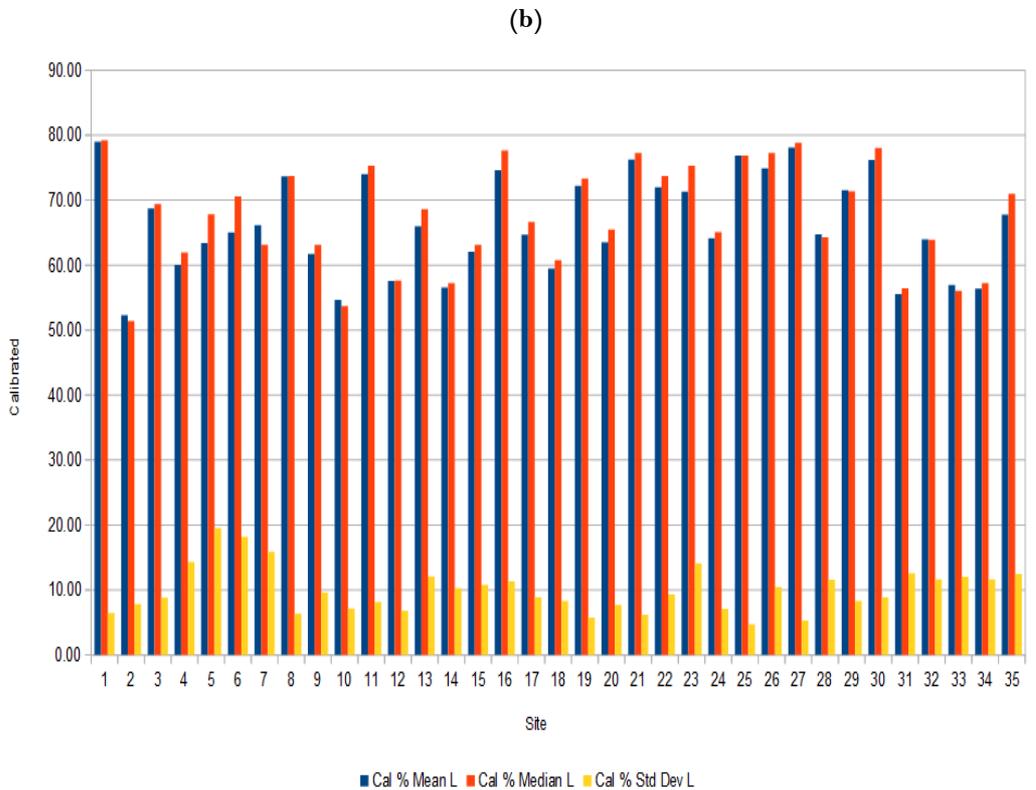
**Fig-4.** Uncalibrated (a) and calibrated (b) results for lightness ( $L$ ), including % Mean, Median, and Std Dev values.

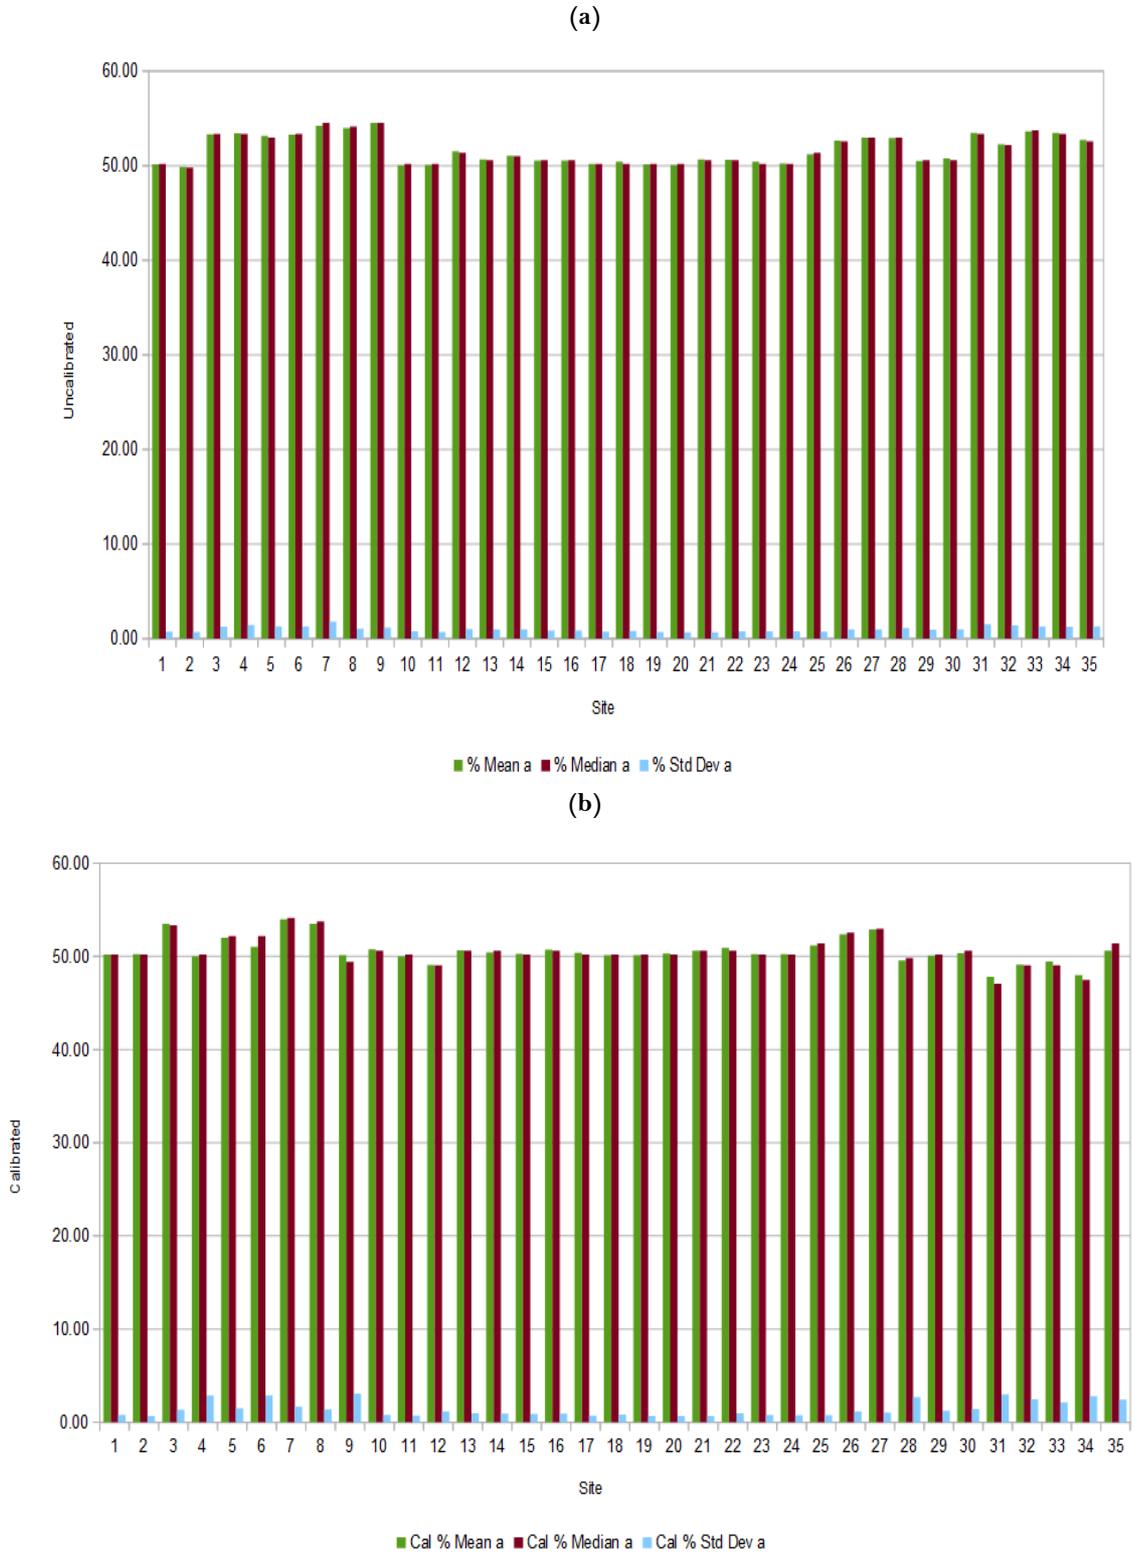
**Fig-5.** Uncalibrated (a) and calibrated (b) results for the green-red color spectrum (a), including % Mean, Median, and Std Dev values.

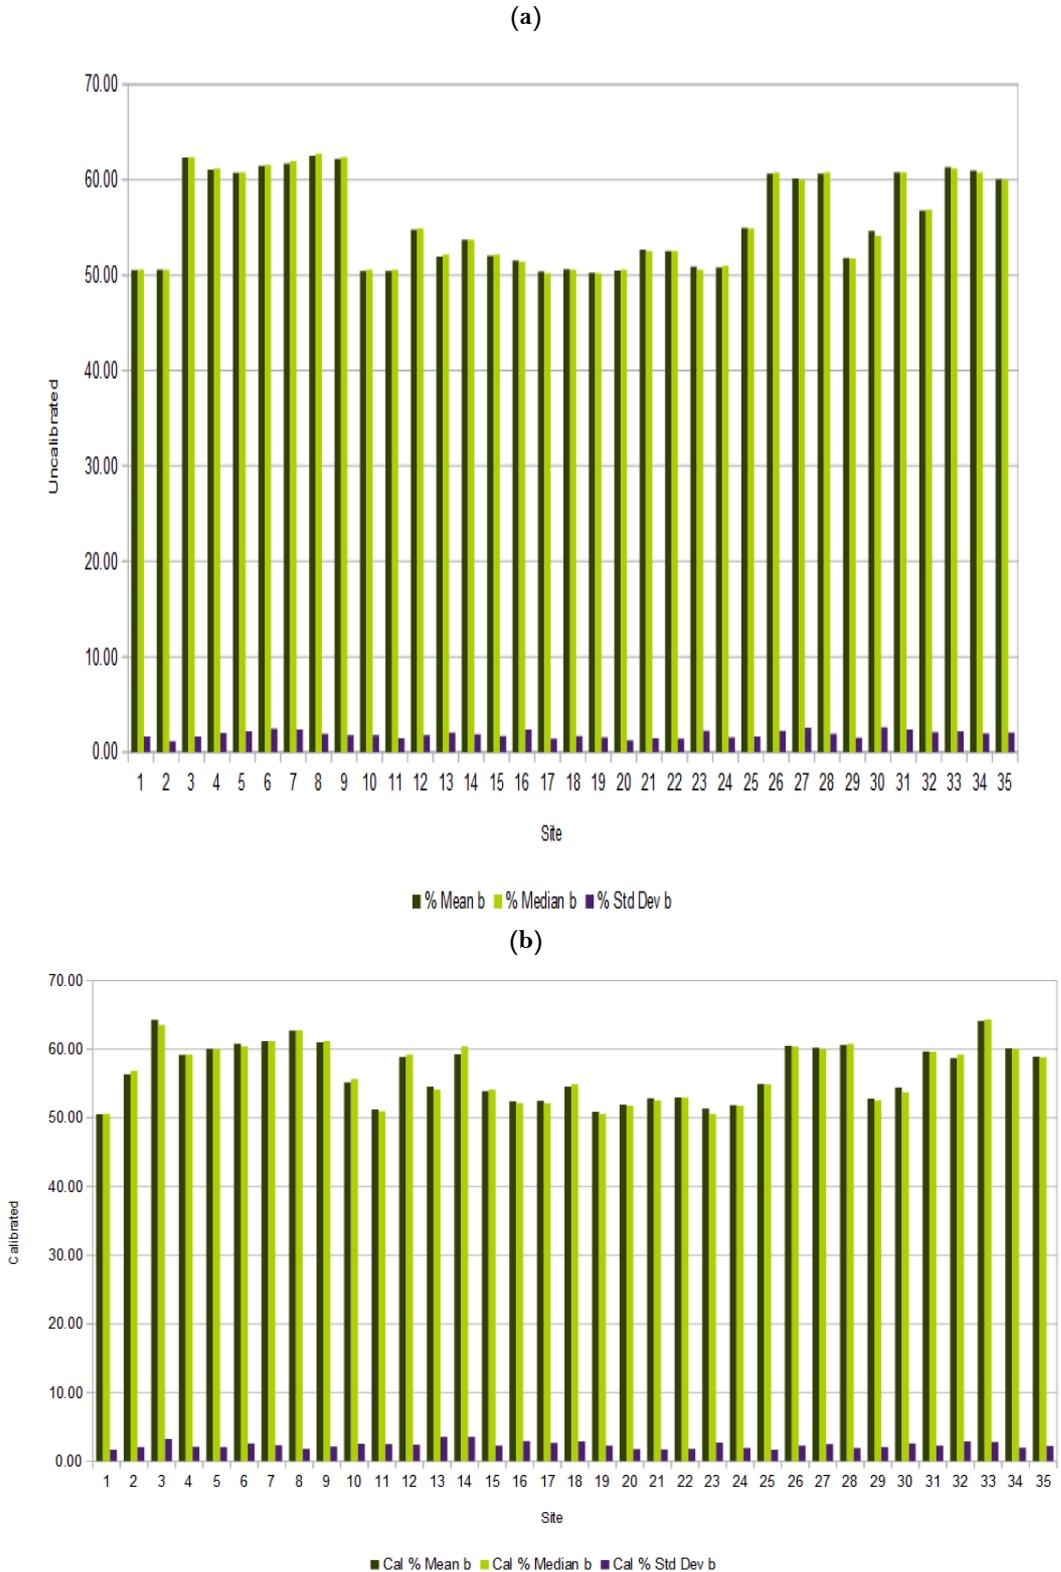
**Fig-6.** Uncalibrated (a) and calibrated (b) results for the blue-yellow color spectrum (b), including % Mean, Median, and Std Dev values.

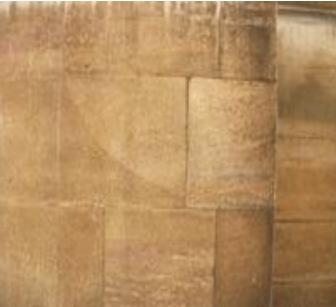
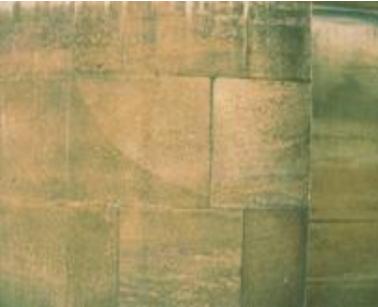
Site: Orientation ( $\times 100$ ) at 50,000 Lux	Uncalibrated Image Mean (Median) Std Dev	Calibrated Image Mean (Median) Std Dev
9: 14° North (120)

$L = 61.71$ (63.14) 10.33% $a = 54.52$ (54.51) 1.16% $b = 62.21$ (62.35) 1.80%

$L = 61.71$ (63.14) 9.59% $a = 50.13$ (49.41) 3.07% $b = 61.03$ (61.18) 2.15%
10: 24° North (142)

The chromatic values also convey similar patterns around the building exterior. For instance, lower values of  $a$  (denoting more greening) appear at Sites 9 and 12 (north-facing). However, Sites 28, 31 to 34 (which are south-facing) are also greener (in the high 40%) than the rest. The redder sites (in the low 60%) are visible also along the south-facing portion of the building (at Sites 5 to 8) and on the west-facing side (Sites 25 to 27; Fig. 5b). Yellowing is evident at some north-facing sites, including Sites 5 to 9, where values are in the low 60% (Fig. 6b). This similarly occurs at Sites 26 to 28 and 33 to 34, which are west- and south-facing, where values are also in the low 60%. The greatest amount of yellowing is evident at Sites 3 (64.26%) and 33 (64.10%). On the other hand, bluing can be seen on images taken at Sites 1, 11, 33, and 34, where  $b$  values are as low as 50.59 and 50.98% (see Fig. 6b). This occurs on a variety of orientations, including east-, north-, and south-facing.

The calibration process seems to have successfully corrected the lighting and color of the images, improving their appearance (as evident in the appendix images). It has not inflated lighting values where more light is shed on walls, as on east- and south-facing walls. Even though some sites where more light is shining also have greater  $L$  values, for instance at Sites 1 and 11 (both with values in the 70%), most west-facing sites (with lower light readings) had high  $L$  values, such as at Sites 21, 25, and 27. The method also picks up on some trends that would be expected, such as greening (with algal colonization on wetter portions of wall [9] on north-facing sections of the building (evident at Sites 9 and 12).

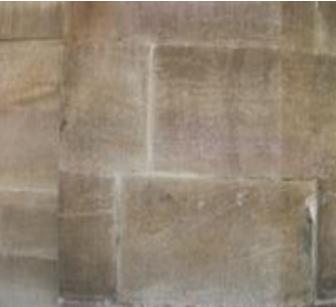
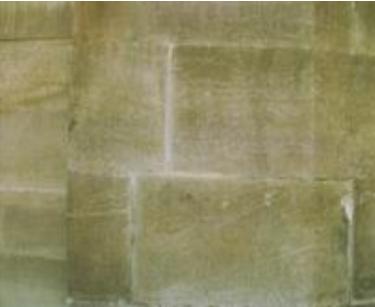
Site: Orientation ( $\times 100$ at 50,000 Lux)	Uncalibrated Image Mean (Median) Std Dev	Calibrated Image Mean (Median) Std Dev
12: 5° North (126)

$L = 56.36$ (56.47) 7.64% $a = 51.50$ (51.37) 1.01% $b = 54.78$ (54.90) 1.75%

$L = 57.55$ (57.65) 6.82% $a = 49.07$ (49.02) 1.16% $b = 58.86$ (59.22) 2.43%
13: 347° North (123)

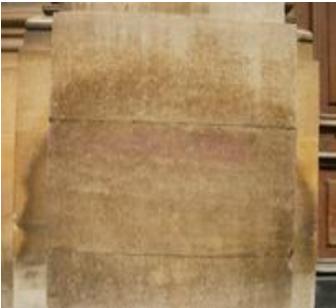
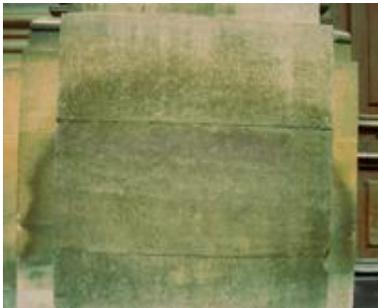
31: 178° South (89)

<p> <math>L = 58.72</math> (59.61) 12.37%  <math>a = 53.46</math> (53.33) 1.51%  <math>b = 60.80</math> (60.78) 2.38%                 </p>

<p> <math>L = 55.58</math> (56.47) 12.60%  <math>a = 47.79</math> (47.06) 3.02%  <math>b = 59.64</math> (59.61) 2.28%                 </p>

As caveats, this study did not consider the maintenance history of the building, and it should be assumed that blocks have been repaired and replaced piecemeal. Indeed, the exterior of the Sheldonian Theatre is well-maintained and does not appear to be soiled like other buildings that remain uncleaned in central Oxford. The age of individual stone blocks could complicate the findings. Also, stone type could be a further consideration, especially since Bath limestone was replaced by harder stone types in the city center [9], such as Clipsham and other limestones. The coloration of these limestones would differ and could affect the results. Other influences could be anthropogenic, such as graffiti appearing on the exterior of buildings, as is somewhat apparent along the south-facing facade of this building; see, for instance, sites located along the southern building exterior (in the appendix), which have a reddish stripe through them that is somewhat visible and could indicate previous cleaning of graffiti (e.g., Site 31).
